Subject: Cylinder head

Affected engine models: All engine models:

L 1700
L 2000

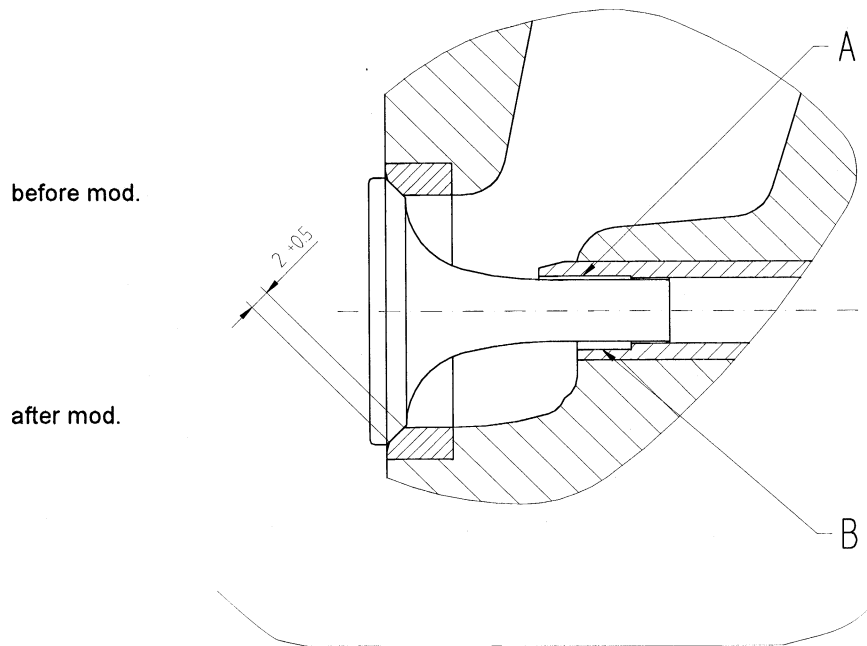
Due to changing fuel recipes, problems with burnt exhaust valves were observed. An investigation showed that increased combustion deposits are responsible for the problem. This has been reported from other engine manufacturers as well. The deposits lead to valve sticking in the lower countersunk area of the exhaust valve guides (see section A in the sketch below). The time span until problems occur depends on the type of aircraft, the condition of the cooling baffles, operating mode of the aircraft, the fuel brand and the engine oil used. Specific brands of fuels cannot be recommended, because their recipes may change locally. The frequency of occurrence is higher with engines which are stressed higher than normal.

Compliance: The exhaust valve guides are milled until flush with the material of the exhaust port. The remaining rest of the countersunk area is enlarged to 9.5 mm diameter. The bottom of the countersink must be perpendicular to the main bore with a sharp edge. This way the ring area around the valve stem is enlarged and the shoulder at the end of the countersink will prevent deposits from entering the valve guide bore. In addition to this measure the width of the sealing face on the valve seat is cut to a width of 2 mm. This should contribute to a reduction of the valve temperature. Replace exhaust valves with new ones. Check condition of cooling baffles and replace if necessary.
