Subject: Cylinder Heads

Affected engine models: All engine models:

L 1700
L 2000
L 2400 EB, EE

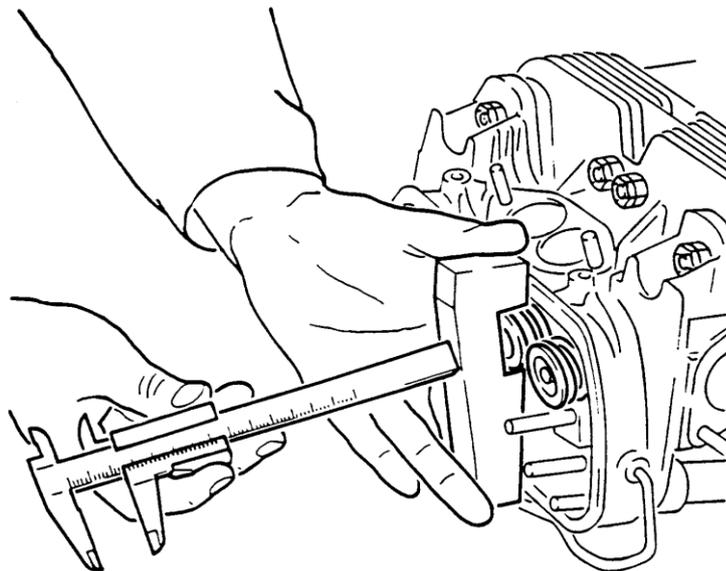
After engine operating times between 500 to 600 hrs. cases of excessive wear on the sealing surfaces of the valves and valves seats has been observed occasionally.

1. Remove valve cover from cylinder head on both sides.
2. Remove rocker arm shafts from both sides (4 Nuts M8).
3. Position measuring device (P/N 803.001.130.000) as pictured over each valve. Measure the distance to the end of the valve with a depth gage. The minimum allowable distance is 24.0 mm for intake and exhaust valves. Replace cylinder heads if out of limits.

4. Assembly in opposite sequence.
5. Apply sealing compound REINZOSIL SI 300 (P/N 708.413.070.000) to the sealingsurfaces of the support bosses for the rocker arm shafts before assembling.
Torque M8 nuts (property class 10) to 25 Nm. Check valve clearance, adjust if necessary.

Caution: If still within limits, but the distance measured already smaller than 24.5 mm, the check must be repeated every 100 hrs.
