**Subject:** Rough engine run and vibrations which may cause engine case cracks.

**Affected engine models:** All engine models

## SL 1700 EA

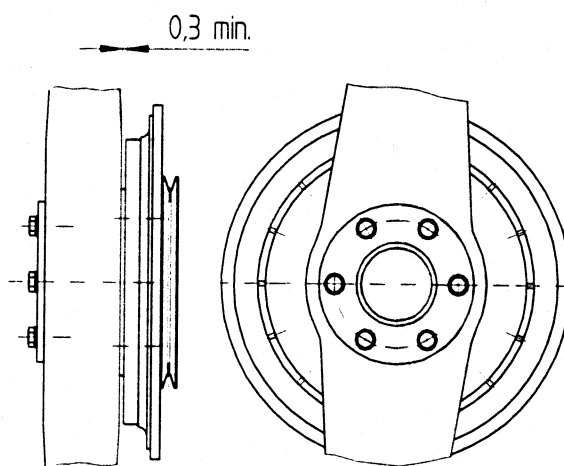
**Background information:** Occasional occurrence of engine case cracks at aft right side below upper engine mount. The cracks have been detected at engines which have been replaced after 1,000 operating hours. These engine showed that the propeller had been in contact not only with the propeller hub but also with the starter disk (spinner attachment ring) (see sketch).

**Compliance:** Check distance between propeller and starter disk front edge by means of a feeler gauge. If the distance is less than 0.3 mm mount an aluminum disk of 1 mm thickness between propeller and starter disk. P/N: 17.03.035 B.
